Tsunami-generating rock fall and landslide on the south coast of Nuussuaq, central West Greenland

Stig A. Schack Pedersen, Lotte Melchior Larsen, Trine Dahl-Jensen, Hans F. Jepsen, Gunver Krarup Pedersen, Tove Nielsen, Asger Ken Pedersen, Frants von Platen-Hallermund and Willy Weng

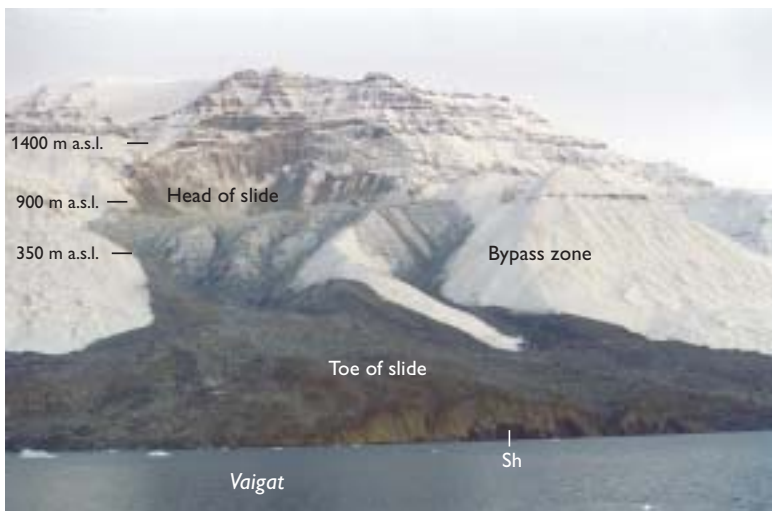
Fig. 1. The 21 November 2000 landslide at Paatuut, viewed from the sea a few days later. The slide lacks snow cover; cf. Fig. 4. Note the black shale (**Sh**) cropping out in the lower part of the coastal escarpment. Photo: Christoffer Schander, Arktisk Station, Qeqertarsuaq.

The morphology and main features of the landslide can be clearly seen in the photographs of Figs 1 and 4, taken respectively a few days after the event and in July 2001. The slide was initiated at altitudes of 1000–1400 m a.s.l., referred to as the head of the slide (Fig. 1). The material transported by the slide comprises partly blocks of basalt that formed a steep scree prior to the slide, and partly solid slabs of basalt broken off from the cliff.

The slide escarpment along which material slipped and slid bounds the head of the slide (Figs 1, 4). The escarpment comprises two steep (*c.* 60°) surfaces, which meet at a high angle. Along the eastern escarpment surface the slip was down-dip, and the vertical offset seen on the denudated surfaces ranges from 121 m to 182 m; this surface is interpreted as a pre-existing fault plane, and the newly exposed rock has a pale colour (Fig. 4). The western surface constitutes a side escarpment which was clearly affected by oblique lateral movement during the landslide event, as indicated by groove mark striation on the cliff. Based on the disrupted character of the landslide material and the

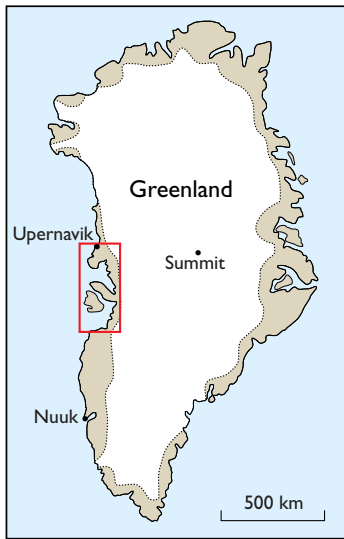
Fig. 2. Geological map of the Nuussuaq Basin with the landslide-prone areas indicated. Frame shows location of Fig. 3, a detailed map of the Paatuut area.

Greenland where gneisses and granites dominate, slides are rare. By contrast, the Nuussuaq Basin comprises weakly consolidated sedimentary rocks overlain by a thick pile of dense volcanic rocks. This stratigraphical succession is favourable to the generation of slides. Consequently, large parts of Disko, Nuussuaq and Svartenhuk Halvø are strongly affected by landslides, especially along the coasts (Fig. 2).

Areas with a high risk of landslides accompanied by tsunamis are found on the south coast of Nuussuaq between Paatuut and Nuusap Qaqqarsua (Fig. 2). Here, the very steep slopes and the active erosion of the thick pile of hyaloclastite breccias generate thick, steep, high-lying debris fans, which are unstable and may easily slide.

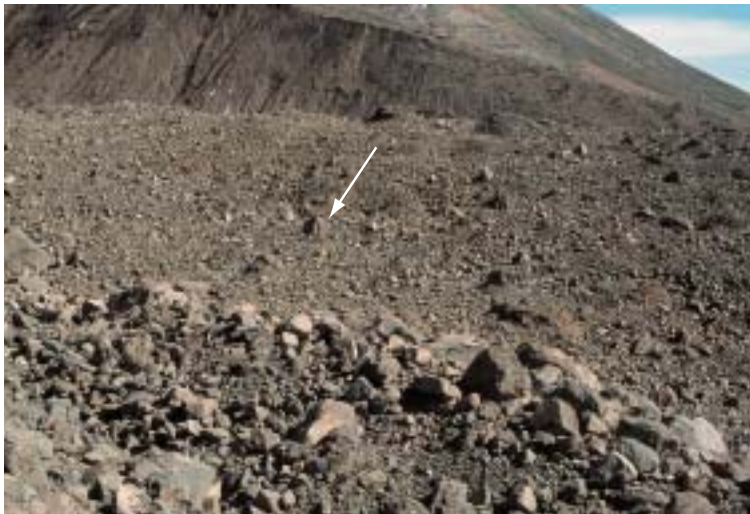
Fig. 5. Blocks and boulders in the central part of the toe of the Paatuut landslide are interpreted as grain flow deposits. **Arrow** indicates person for scale. Photograph taken July 2001.

Morphologically the lower part of the slide comprises two lobes which merge downwards into one, with a surface lined by trenches, ridges and flats (Figs 4, 5). The floors of the trenches may be as much as 50 m below the crests of the ridges. The alluvial fan upon which the landslide was deposited had a dip of 6° – 9° ,

and the aggradation is up to 60 m (see later). The ridges consist of clast-supported, apparently matrix-free conglomerates and are interpreted as grain flow deposits. The flats consist of clast-supported, matrix-bearing conglomerates and matrix-supported conglomerates, indicating deposition from modified grain flows and debris flows. In the flat areas frost mounds are common, indicating the presence of fine-grained sediment at the base of the deposit.

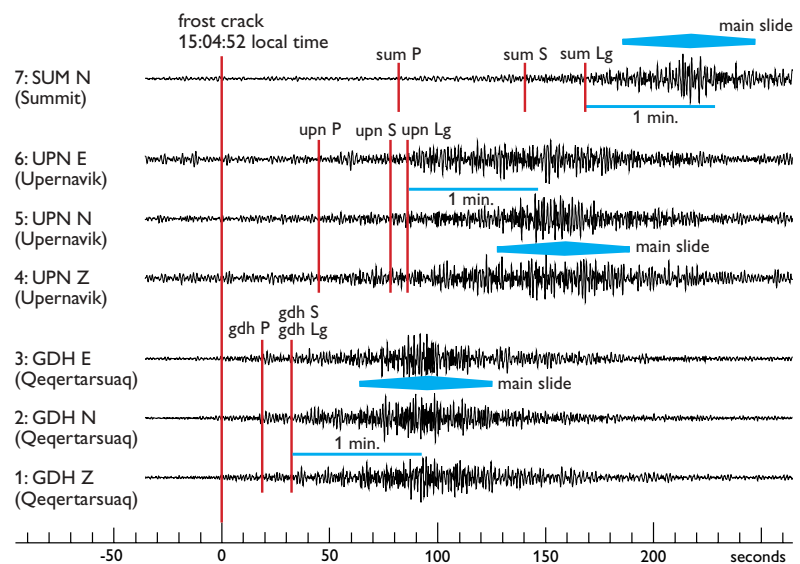
Fig. 6. Seismic events related to the rock fall and landslide at Paatuut 21 November 2000 recorded at Qeqertarsuaq, Upernavik and Summit (Fig. 2). The **red lines** mark the calculated arrival times of **P** (primary), **S** (secondary), and **Lg** (surface) waves from an initial release event at Paatuut. The time is determined by interpreting the P arrival at Qeqertarsuaq. The initial release of the fall occurred at 18:04:52 GMT (15:04:52 local time) and generated P, S and Lg waves. Subsequently, the energy released by the sliding of 90 million m³ of rocks down onto the coastal slopes is visible as an additional surface wave culminating approximately one minute after the initial event. This second and much larger event – estimated at 2.3 on the Richter scale – is also visible in seismograms from Nuuk, Tasiilaq, Thule and possibly Alert in Canada. **E**, **N** and **Z** are the east–west, north–south and vertical components in the ground movements.

A seismometer at Qeqertarsuaq registered a distinct seismic signal on 21 November 2000 at 15:05:10 local time (Fig. 6). People in Saqqaq noted that the tsunami arrived at 15:15, and the seismic signal is thus clearly

related either to the landslide itself or to an earthquake which triggered the landslide. Seismic stations at Upernavik *c.* 250 km north of Paatuut and at Summit, the drilling camp at the centre of the Inland Ice *c.* 550 km to the east (Fig. 2), also registered a seismic event on 21 November 2000 (Fig. 6). An analysis of the seismic records suggests that a seismic event occurred at 15:04:52 at Paatuut, and that it was probably caused by the release of the basaltic cliff at the head of the slide (Pedersen *et al.* 2001). This event is seen as the arrival of the primary wave (P) and secondary and surface waves (S and Lg) at all stations (Fig. 6). The following stronger signal reflects the surface waves generated by the activity of the avalanche, estimated to have a magnitude of 2.3 on the Richter scale. The constant time difference between the surface waves from the first and the second events at seismic stations at increasing distances from Paatuut indicates that the two seismic signals were generated at Paatuut, separated by approximately one minute. The main slide event was accomplished within approximately 80 seconds. With an average slide distance of 3 km, this implies an average slide velocity of 140 km/h. Maximum velocities would have been close to 200 km/h.

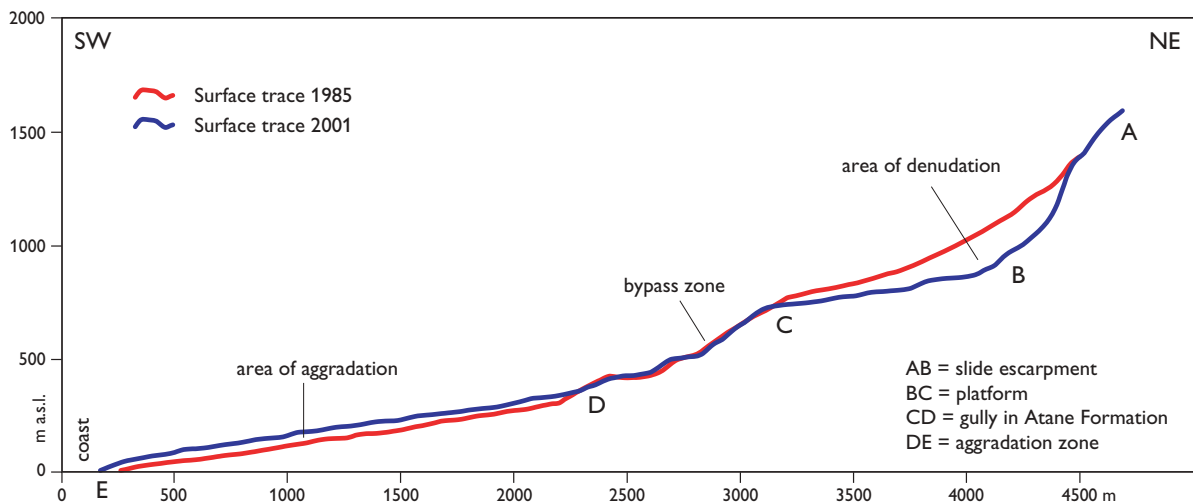
Fig. 7. The relationship between denudation (removal) and aggradation (deposition) regimes in a vertical topographic profile along the landslide area, based on aerial photographs from 1985 and 2001.

Photogrammetrical mapping at the Survey has provided two topographical models of the terrain around Paatuut before and after the landslide. The first model was based on vertical aerial photographs taken in 1985 (scale 1:150 000), and the second model on oblique colour stereo photographs taken with a small-frame camera from a helicopter during the field work in July 2001. From these models (Fig. 7) the volume of displaced material (denudation) has been calculated to *c.* 90 million m³. The subaerial volume of the toe of the slide (aggradation) amounts to *c.* 60 million m³, which indicates that *c.* 30 million m³ of rock material entered the sea giving rise to the tsunami.
