**Low- and intermediate level radioactive waste  
from Risø, Denmark. Location studies for  
potential disposal areas. Report no. 7**

Characterization and description of areas  
Langeland, Tåsinge and Fyn

Peter Gravesen, Bertel Nilsson,  
Stig A. Schack Pedersen  
& Merete Binderup

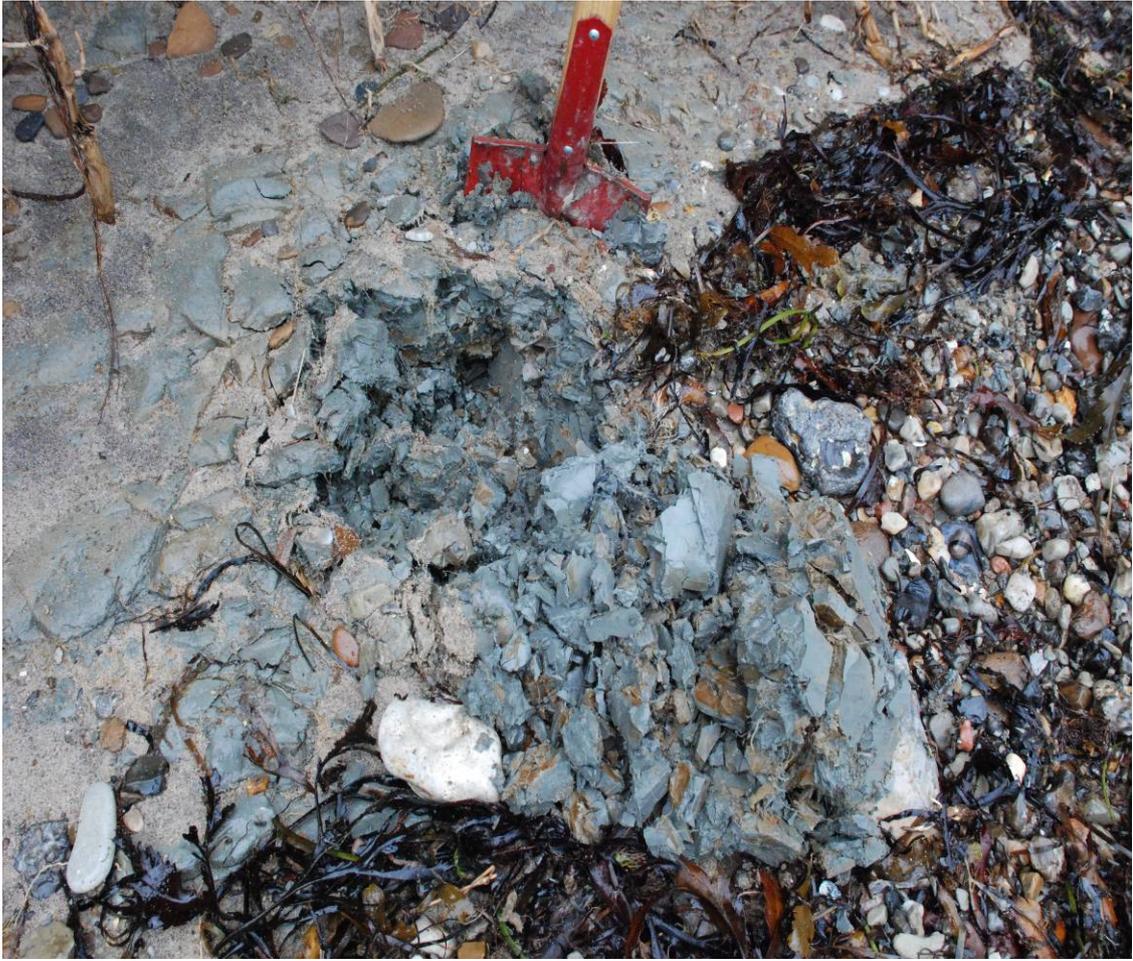
*Figure 8. Green plastic clay, probably the Eocene Lillebælt Clay Formation from Albæk Hoved Cliff, Jylland.*

According to the map of the pre-Quaternary deposits (Fig. 7), the sediments below the Quaternary should belong to Eocene. The relatively few borehole samples are mainly lithological described as plastic, very fine-grained strongly calcareous to calcareous brown and red brown clay or green calcareous plastic clay. One green sample is dated by foraminifera to the Eocene. The clays could tentatively belong to the following formations: The green clays to the Lillebælt Clay Formation and the brown to the Røsnæs Clay Formation. Examples of the two clayey types can be seen in figs. 8 and 9.

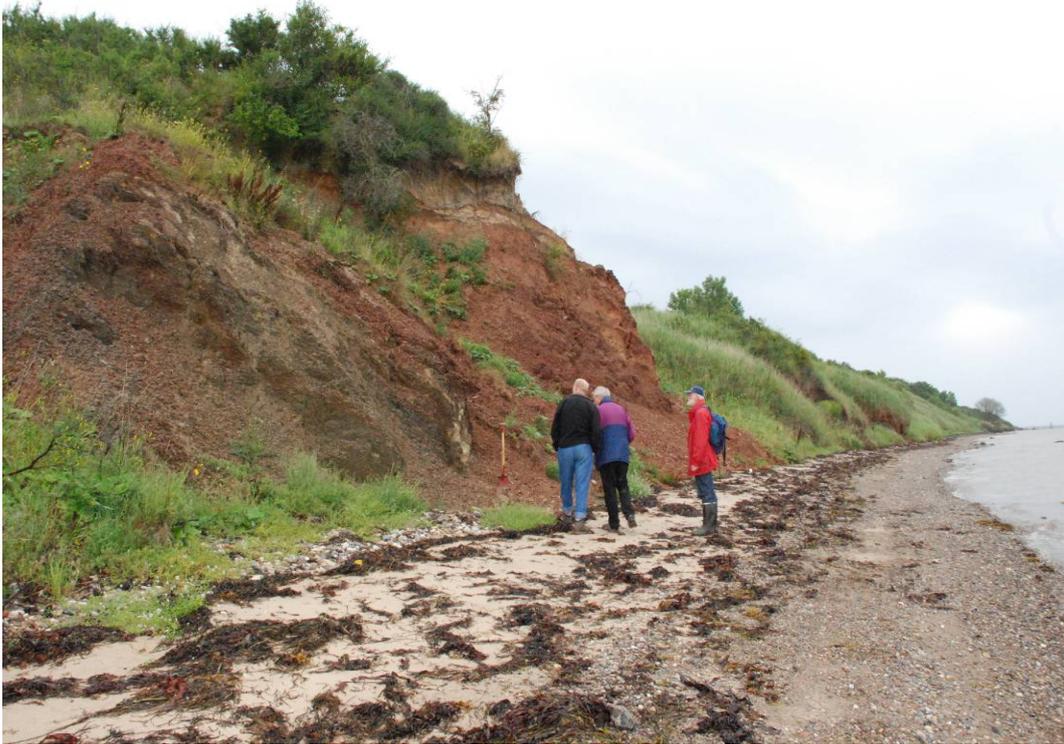
*Figure 9. Section from the Albæk Hoved cliff, Juelsminde, Jylland. Red and green plastic clays which are comparable clays with the Lillebælt Clay and Røsnæs Clay Formations.*

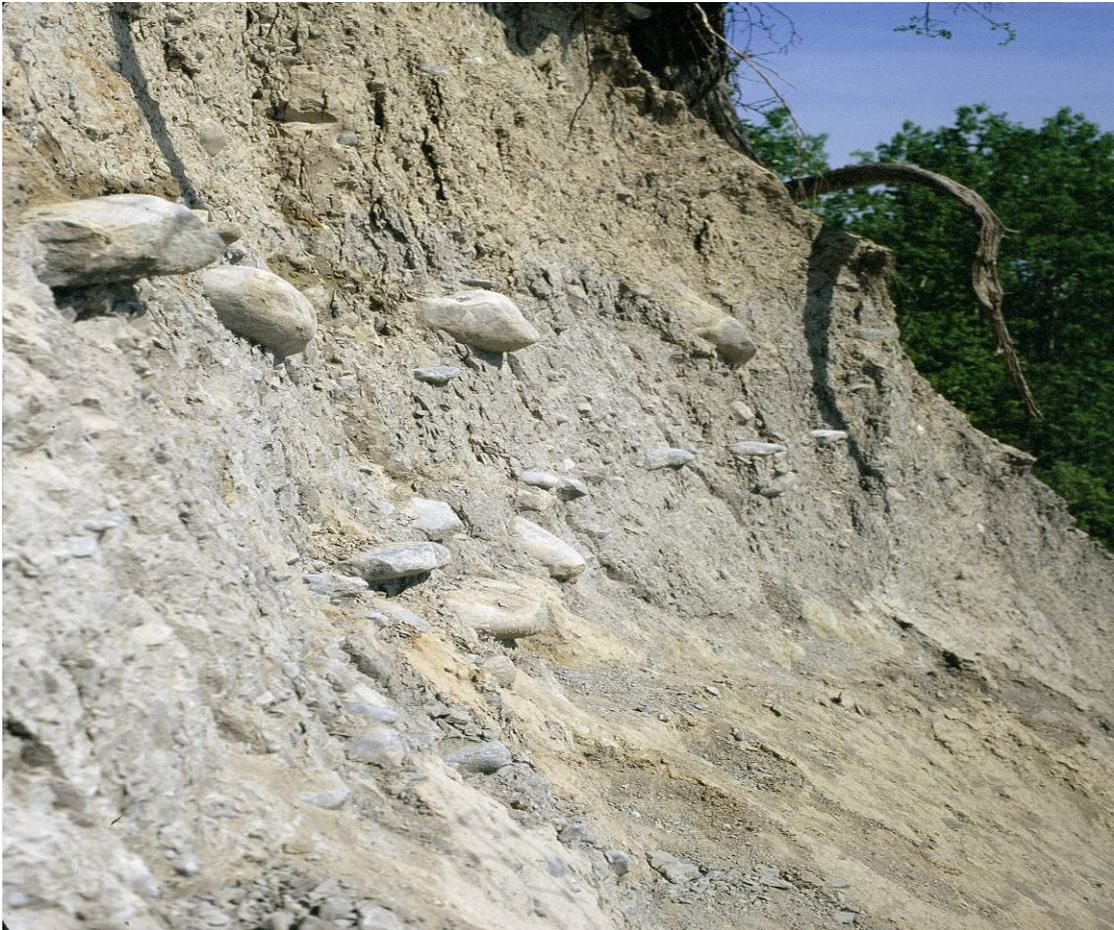
*Figure 11. Example of clayey, sandy and stony till deposits.*

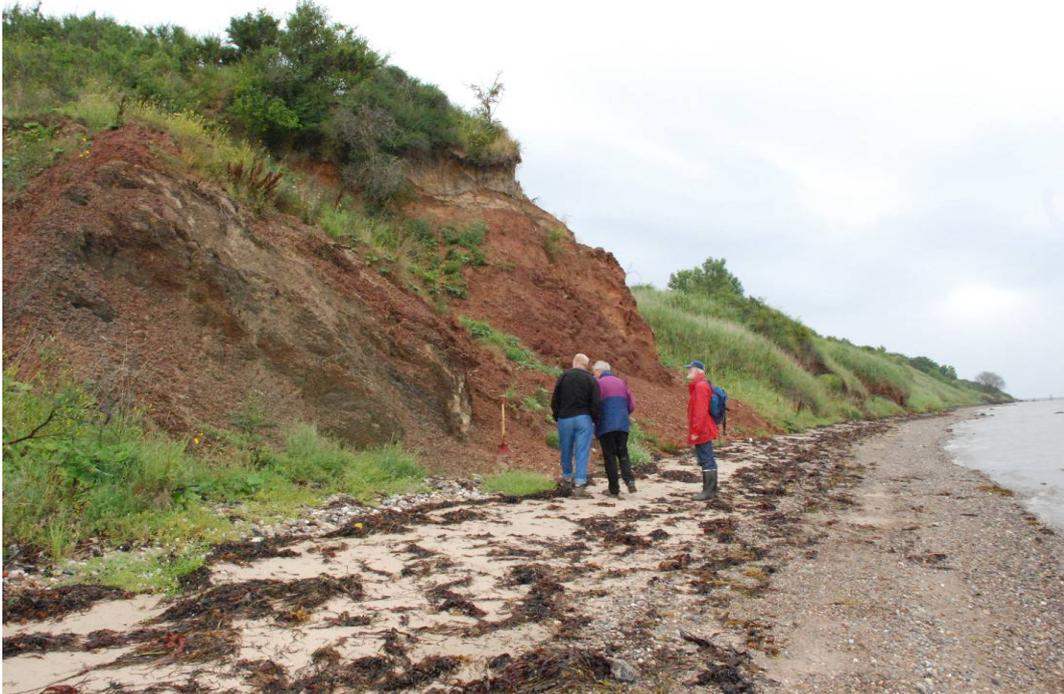
Figure 32. Section from the Albæk Hoved cliff, Juelsminde, Jylland. The plastic clay is lithological comparable to the plastic clays from the Røsnæs and Lillebælt Formations.

The Eocene plastic clays have red, brown, grey and green colors often with volcanic ash layers in the red and brown parts. The clays are very fine-grained and calcareous or non-calcareous. Some samples contain glauconite. It is difficult to distinguish between the Røsnæs Clay Formation and the Lillebælt Clay Formation in the area but the Røsnæs clay is nearly always calcareous. The Eocene deposits are approximately 20-40 m thick in the central part of the area and probably 25 m at Tullebølle (if present)(Fig. 32).

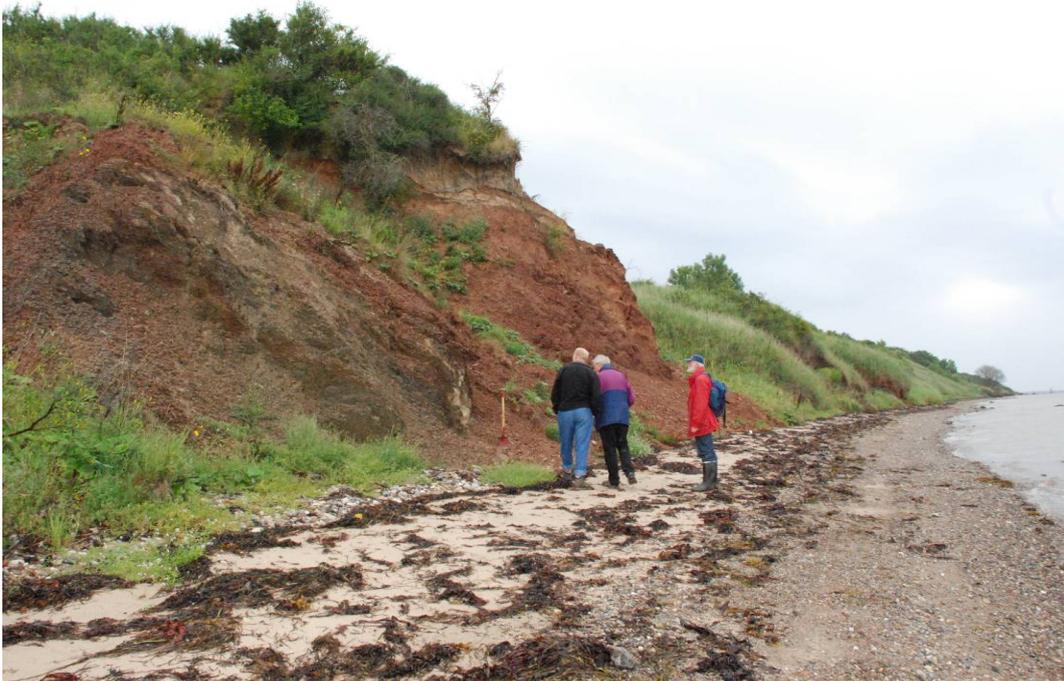
*Figure 52. Section from the Albæk Hoved cliff, Juelsminde, Jylland. Red and green plastic clays comparable to the plastic clays Holmehus Formation.*

Paleogene clays occur between 2 and 25 m below ground surface at Vemmenæs. Towards the south, the layers consists of fine-grained to silty olive grey and olive green clays containing volcanic ash layers. The clays are non-calcareous and are at least 17 m thick. Towards the east, the clay is fine-grained, green and olive green calcareous or non-calcareous. A faint lamination seems to occur and here the thickness is at least 18 m. It is difficult to include the deposits into formal units but the clays could belong to the Paleocene Holmehus Formation (Fig. 52).

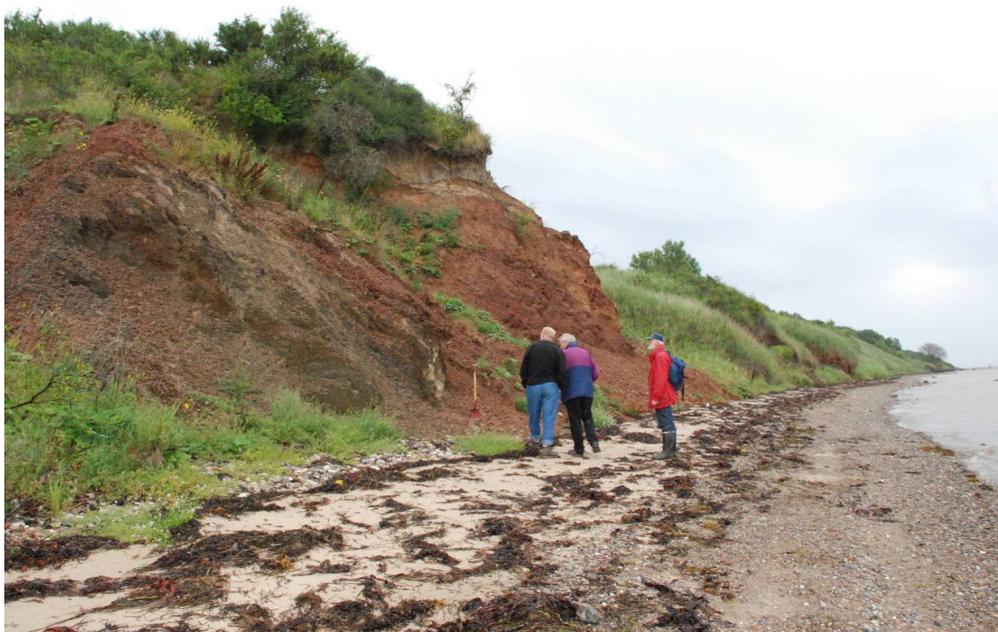
Figure 86. Section from the Albæk Hoved cliff, Juelsminde, Jylland. Red and green plastic clay from the Lillebælt Clay Formation and the Røsnæs Clay Formation.

The Late Oligocene deposits rest on 32 m Eocene Søvind Marl Formation of sticky calcareous clay, 35 m grey plastic clay from the Eocene Lillebælt Clay Formation, 14 m red plastic clay from the Eocene Røsnæs Clay Formation, 10 m clay with volcanic ash from the Eocene Ølst Formation, 37 m fine-grained clay with glauconite from the Paleocene Kerteminde Marl, and at last 6 m Bryozoa limestone with flint from the Danian (see DGU no. 134.226). Some of the sediment types can be seen in fig. 86.

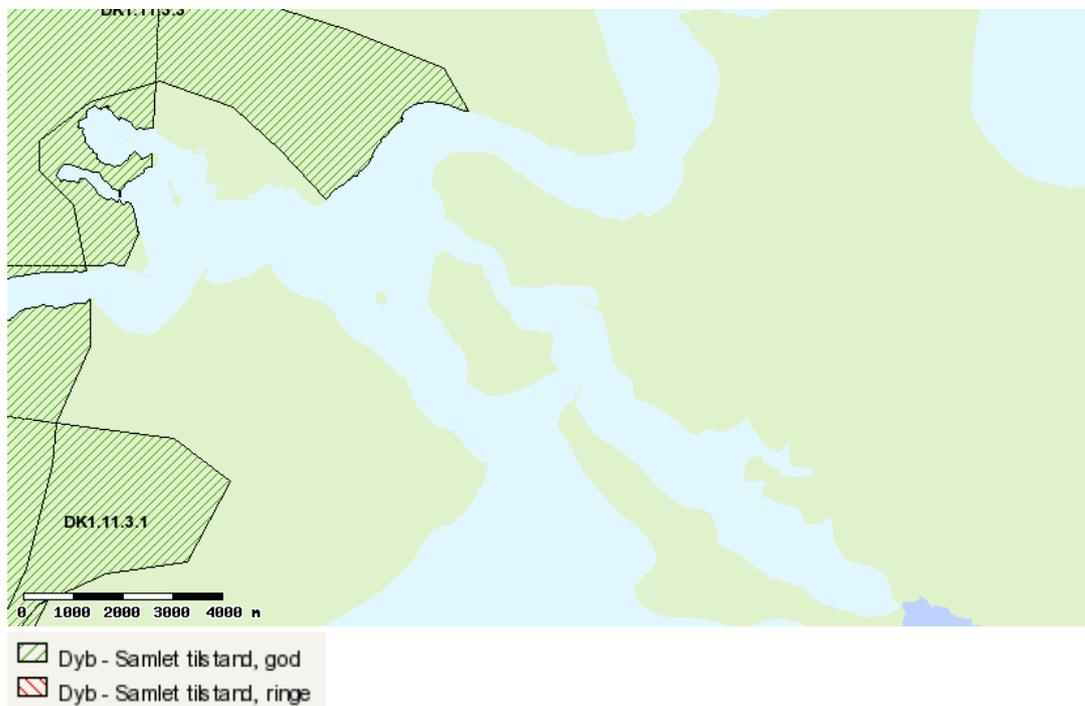
Figure 93. Deep groundwater bodies in Jylland west of Lillebælt (After Ministry of Environment, 2010).
